### Catholic Chaplain's Quarters

### Building 14

# Structural Maintenance and Treatment Plan - Exterior

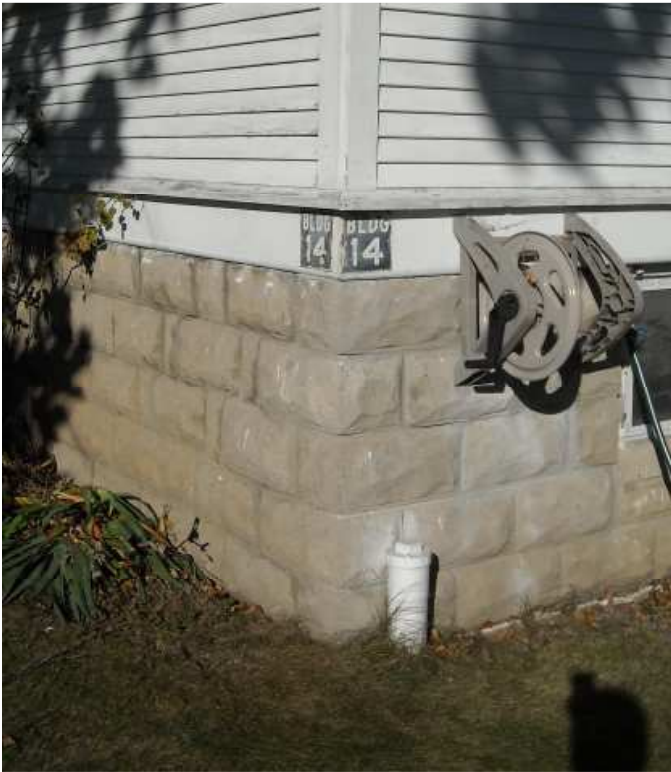
**1** Paint stains at stone masonry foundation.

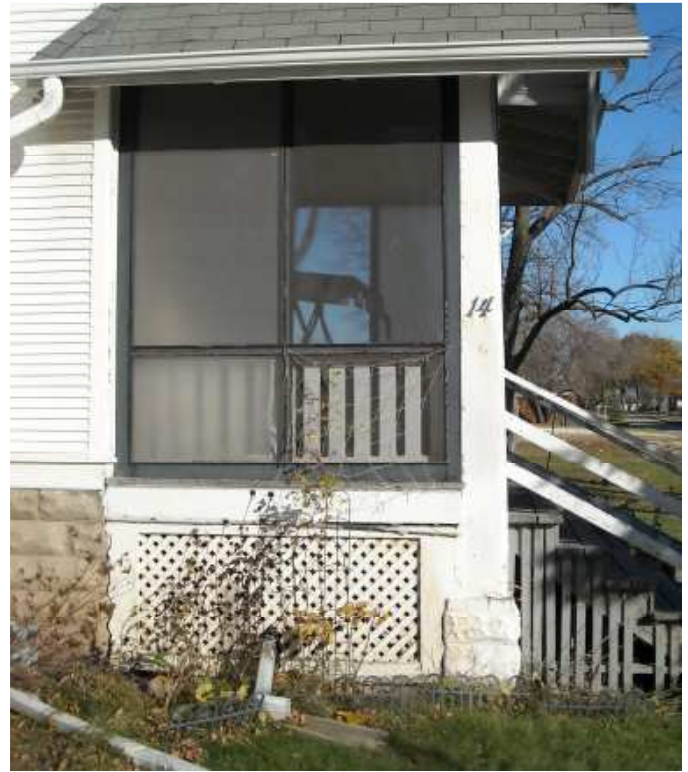
**2** Dirt build-up on wood latticework.

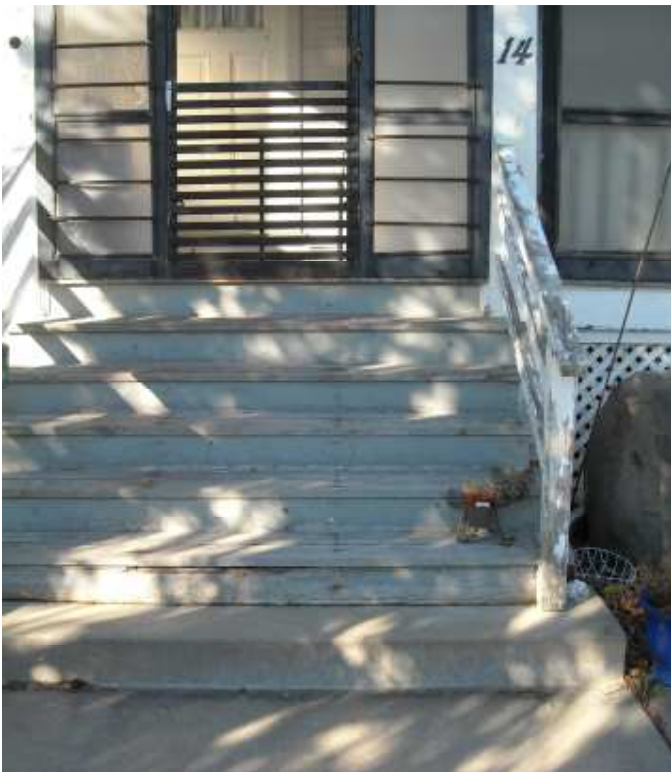
**3** Peeling paint at wood stair and door.

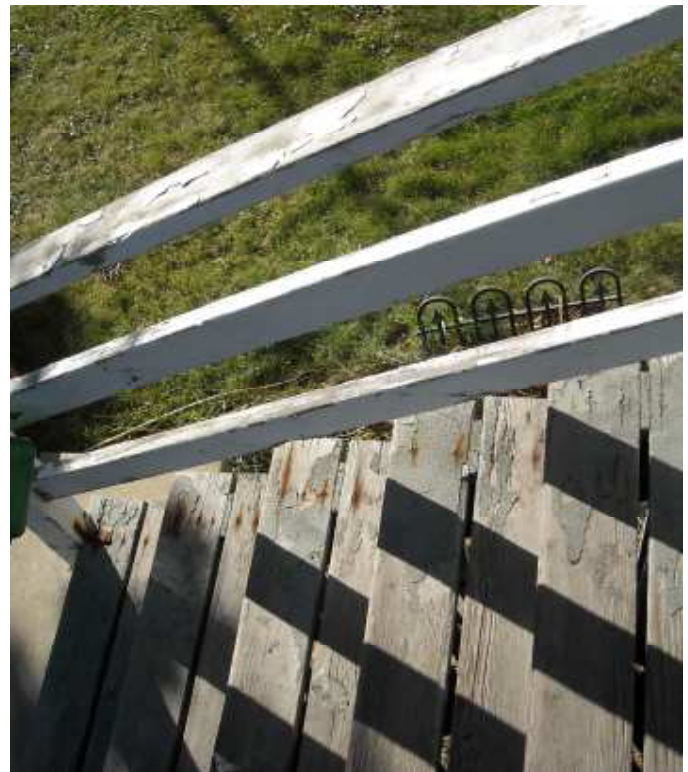
**4** Peeling paint; advanced structural deterioration.

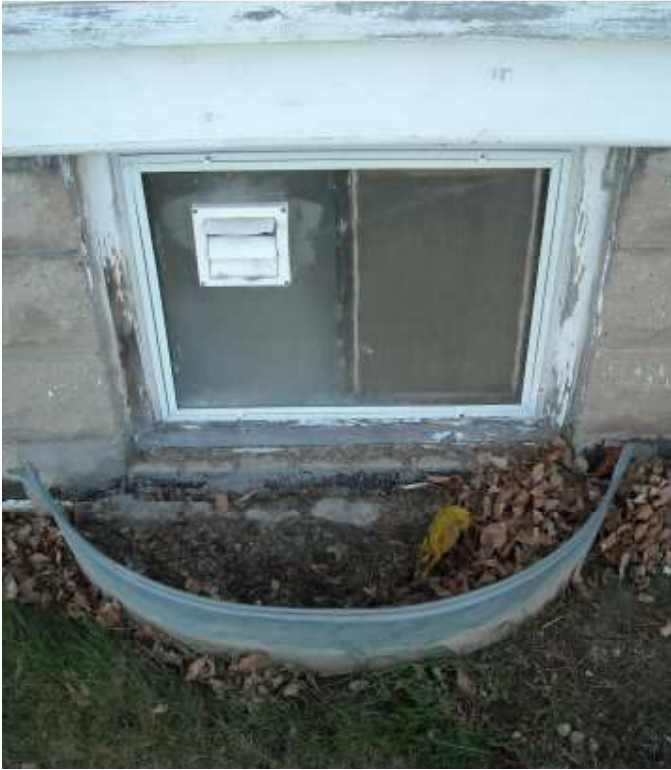
**5** *Peeling paint at window trim.*

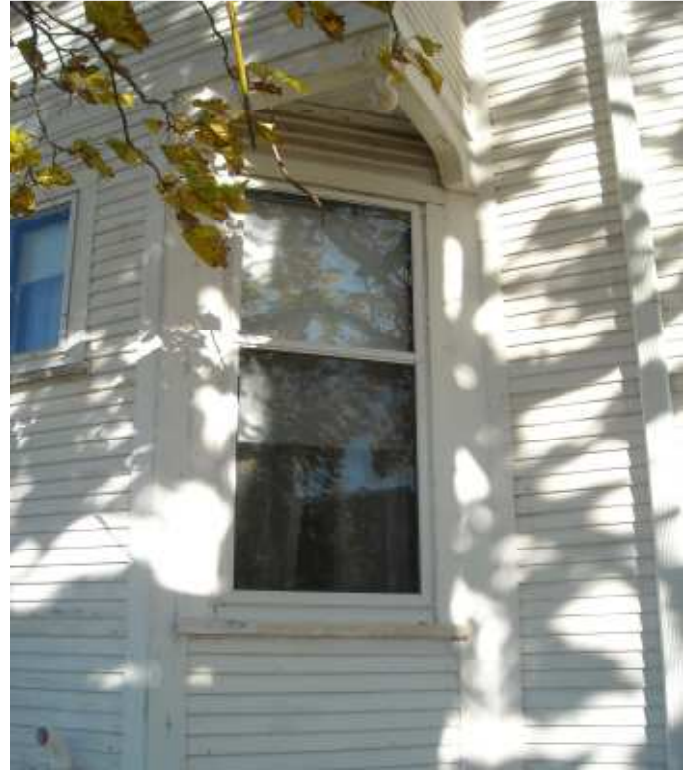
**6** *Inappropriate material at windows.*

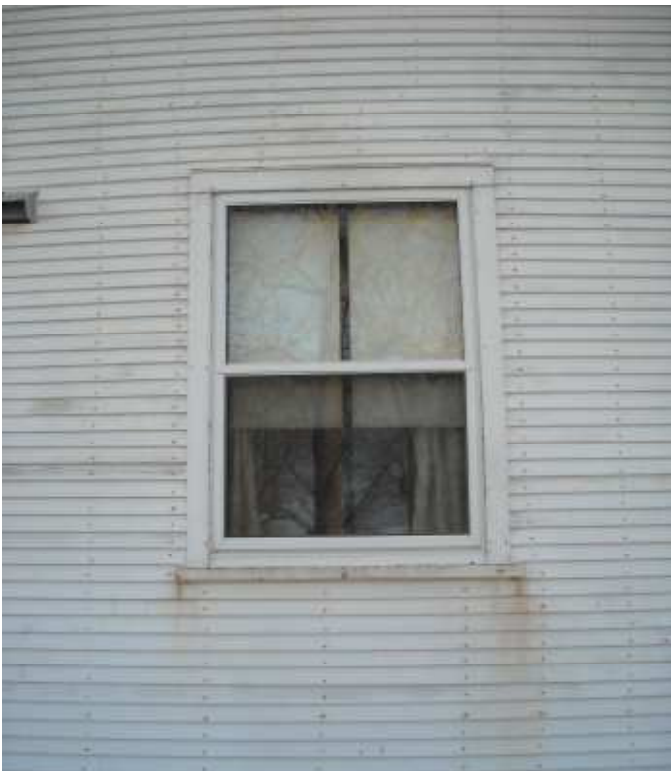
**7** *Dirt build-up; inappropriate material and deteriorating caulk at windows.*

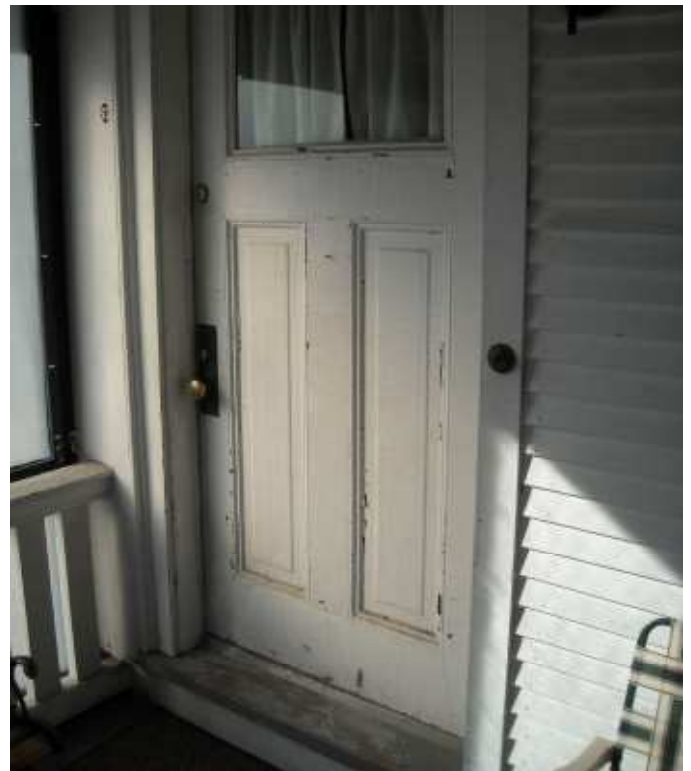
**8** *Peeling paint.*

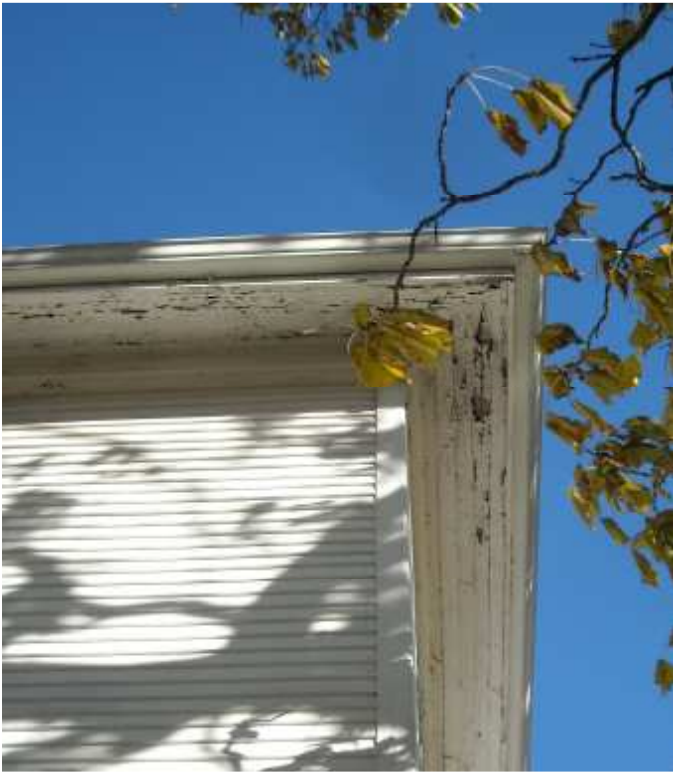
**9** Peeling paint and deterioration at soffits.

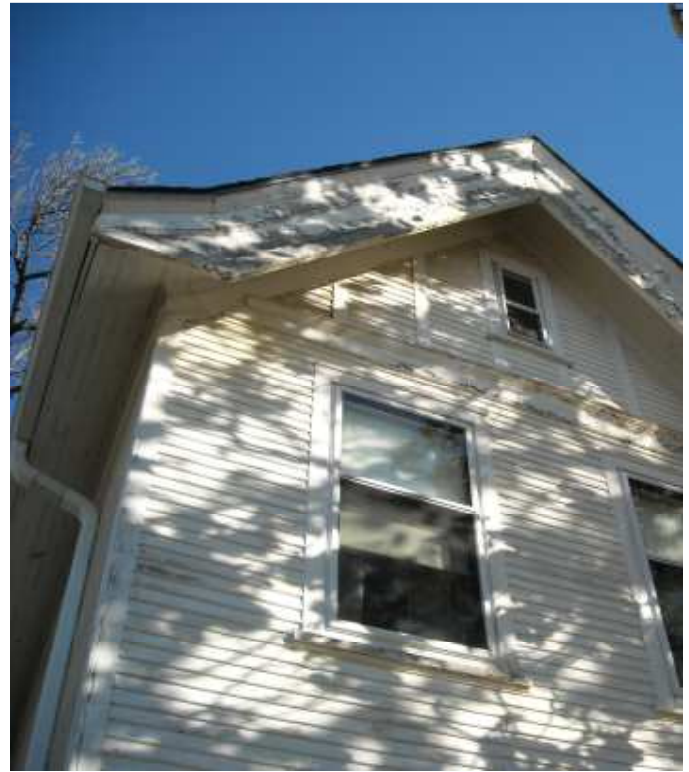
**10** Peeling paint and deterioration at fascia and soffits.

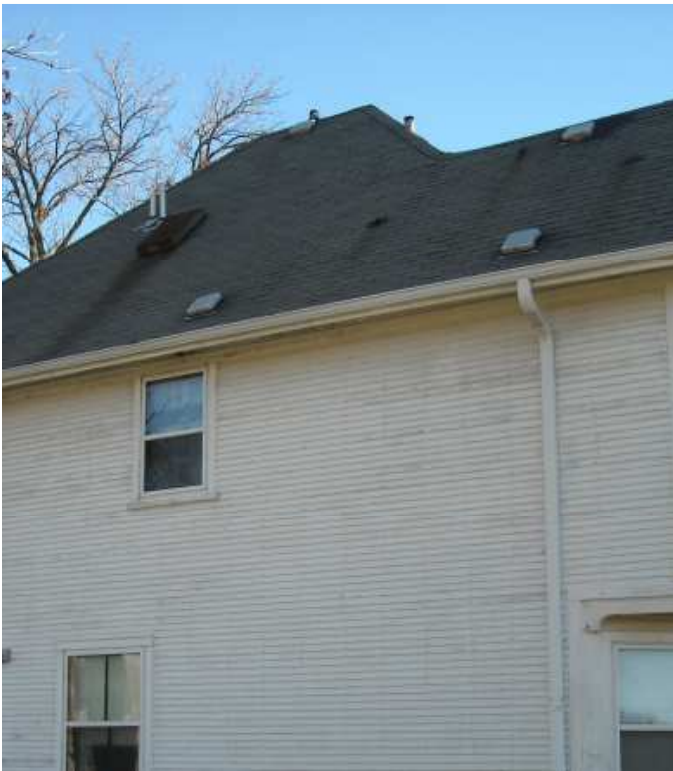
**11** Asphalt shingle stains.

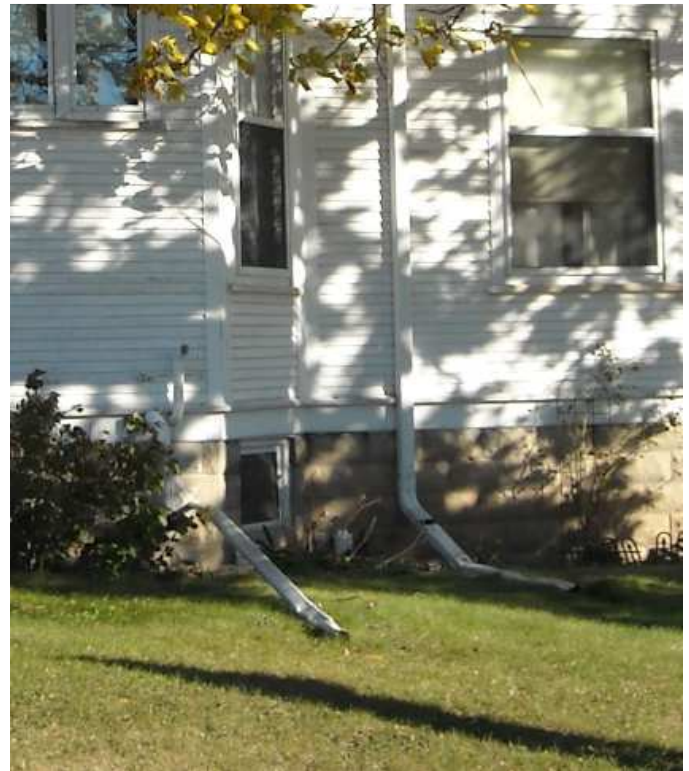
**12** Damaged downspouts.

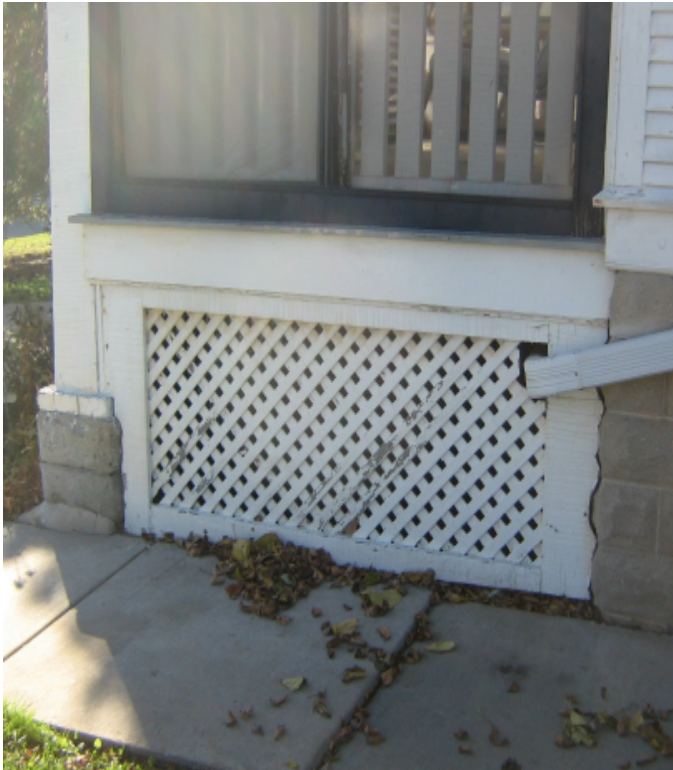
Secondly, the wood framed exterior patio has experienced significant structural deflection and differential movement. This differential movement between patio and the building itself has caused this entire patio to begin to pull away from the rest of the building, causing significant structural sagging and additional failures to all associated floor, wall, and roof framing.

MODERATE REPAIRS ARE NEEDED FOR THE COVERED PATIO & ASSOCIATED STAIRS. DETERIORATION OF THE EXPOSED WOOD HAS TAKEN PLACE OVER TIME. IN ADDITION, THE EXTERIOR PATIO FLOOR HAS A SIGNIFICANT SAG & WARP TO IT. THE PATIO & ASSOCIATED STRUCTURE HAVE FALLEN AWAY FROM THE BUILDING ITSELF. THE ASSOCIATED FOUNDATION WORK FOR THESE PATIOS HAS CRACKED IN VARIOUS LOCATIONS. THESE ITEMS SHOULD BE ADDRESSED IN THE NEAR FUTURE TO PREVENT FURTHER STRUCTURAL DAMAGE.

**Photo 1:** Severe Warping & Structural Deflection of Exterior Patio.

In regards to the floor construction associated with the covered exterior patio where noticeable structural deflection differential movement has occurred, further structural analysis is advised to help determine the extent and type of repairs needed. Structural shoring & additional floor framing may be required to prevent further structural damage.

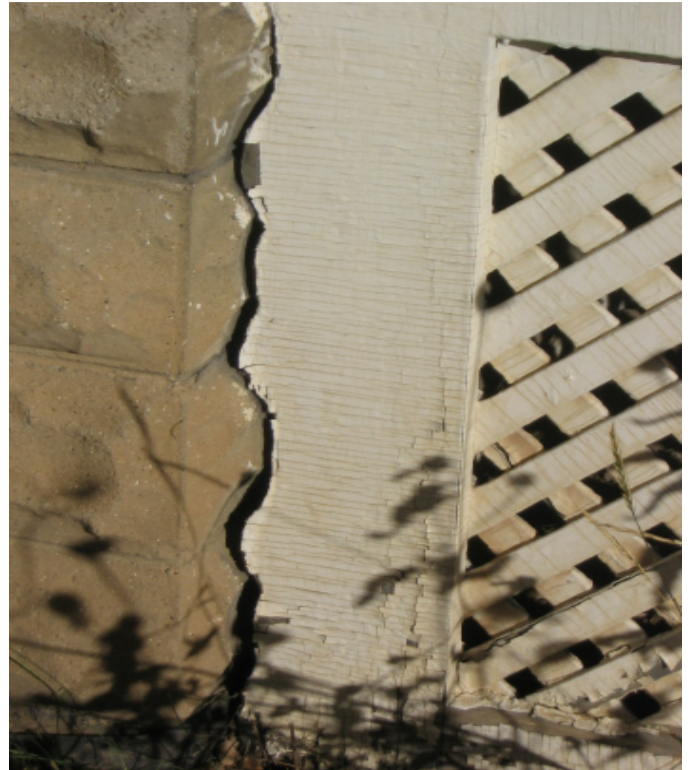
MODERATE REPAIRS ARE NEEDED FOR THE FOUNDATION WALLS AS NOTED BELOW AS CRACKING TO THE EXISTING CONCRETE FOUNDATION WALLS HAS TAKEN PLACE. THE PRIMARY AREA OF CONCERN IS THE EXISTING THE FOUNDATION WORK FOR THE SCREENED IN PATIO, AS SIGNIFICANT CRACKING IN THE FOUNDATION WALLS HAVE TAKEN

**Photo 2:** Deterioration & Cracking at Existing Patio Concrete Foundation Walls.

Re-pointing of all existing masonry stone walls where cracking and deterioration has occurred should be addressed in the near future. Cleaning & removal of the surface deterioration that is currently present would also be recommended.

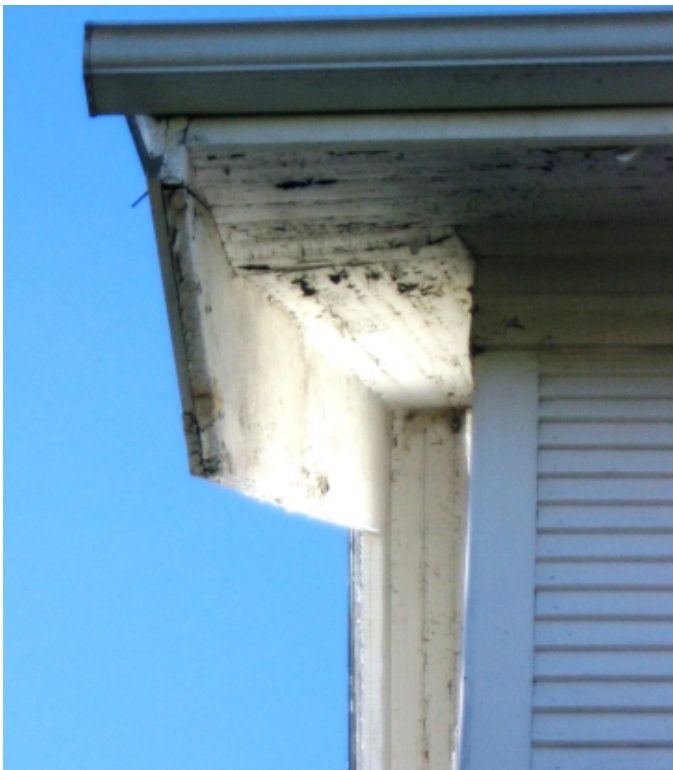
The existing wood roof framing associated with the exterior patio was also found to be in 'good' condition. Again, in this instance, there is a presence of significant moisture damage & surface deterioration as evidence by the surface discoloration of the exposed wooden members. In some instances, many of the painted exterior finishes are badly chipped and peeling away. This applies primarily to the exposed wood posts & support beams associated with this patio roof construction.

**Photo 3:** Deterioration of Exposed Wood Roof Framing & Associated Boards.

In general it is recommended that all exposed interior & exterior wood roof framing be cleaned and refinished to prevent further weathering and deterioration. Wood members that are structurally compromised should be replaced.

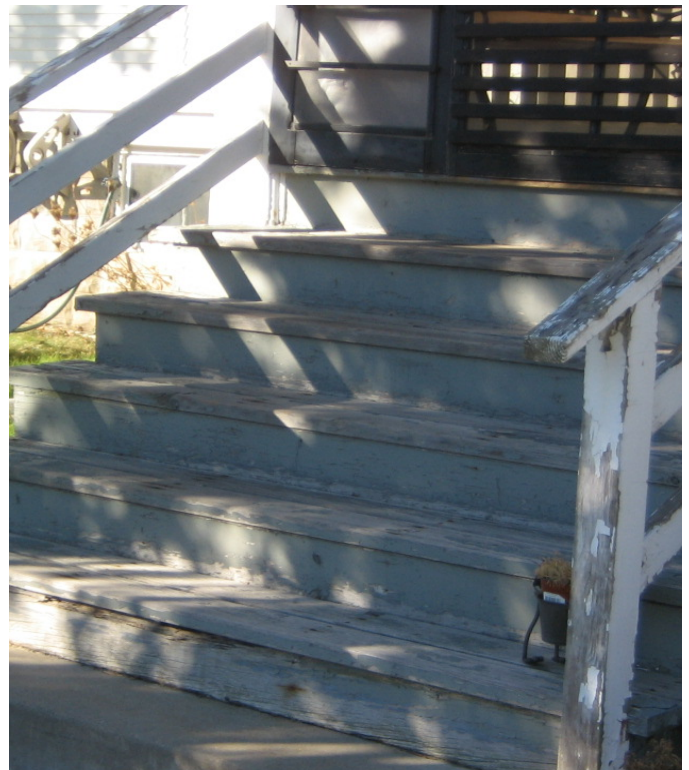
**Photo 4:** Deterioration of Exterior Wood Stair & Associated Framing.

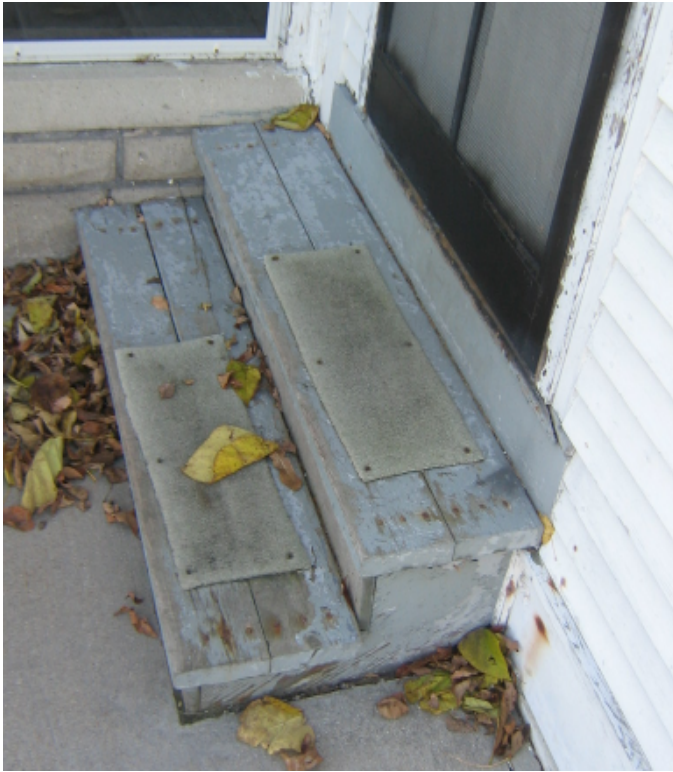
**Photo 5:** Deterioration of Exterior Wood Stair & Associated Framing.

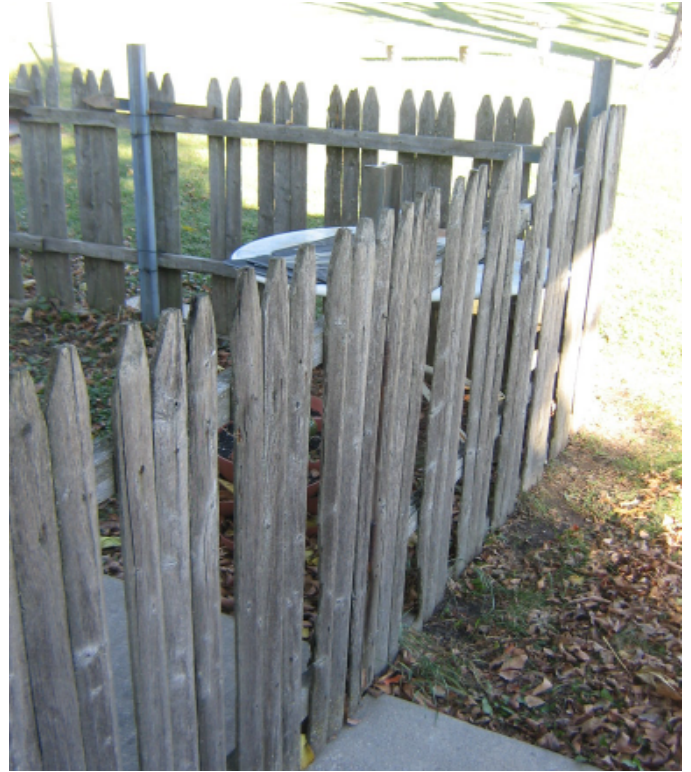
**Photo 6:** Deterioration of Exterior Wood Fence Enclosure.

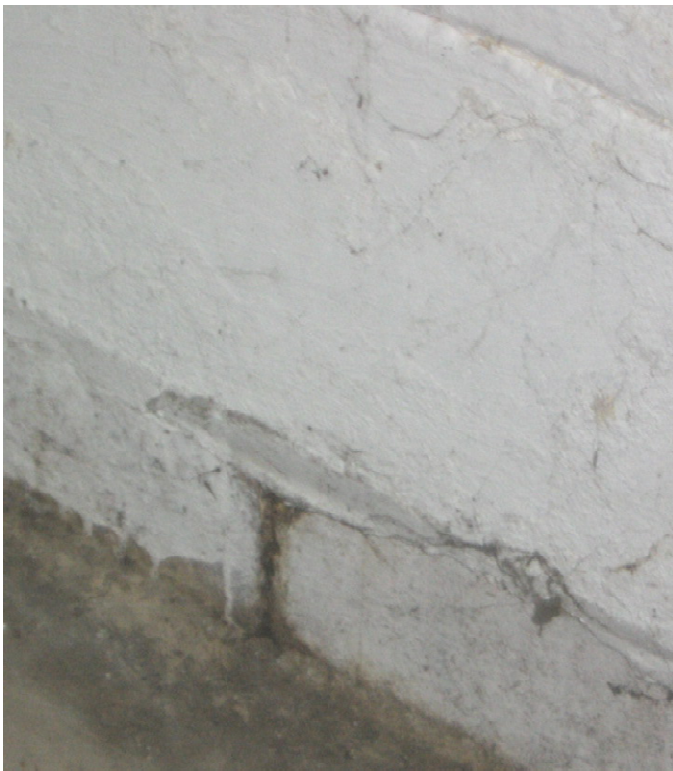
MODERATE REPAIRS ARE NEEDED FOR THE FOUNDATION WALLS AS NOTED BELOW AS CRACKING TO THE EXISTING CONCRETE FOUNDATION WALLS HAS TAKEN PLACE.

**Photo 7:** Cracking & Deterioration of Existing Concrete Foundation Walls.

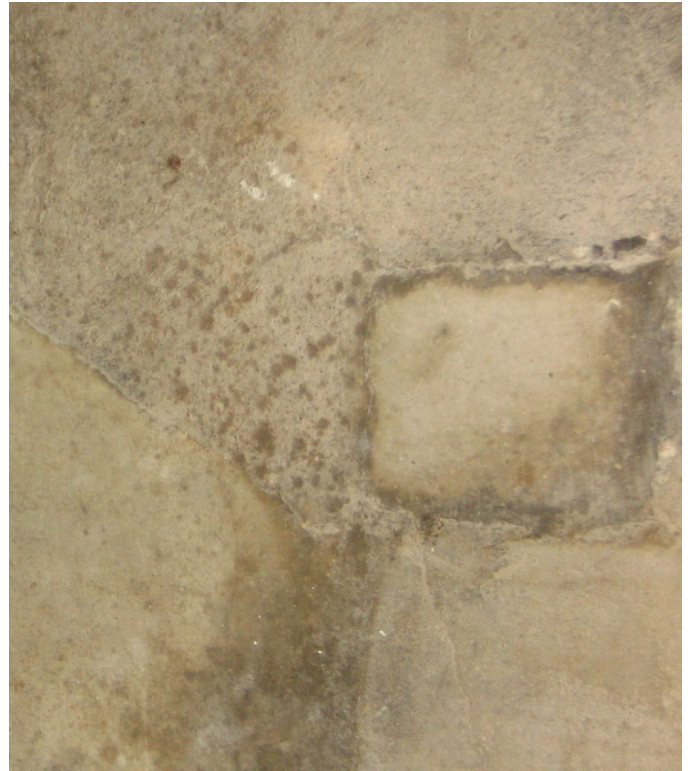
**Photo 8:** Cracking & Deterioration of Existing Concrete Floor Slab.

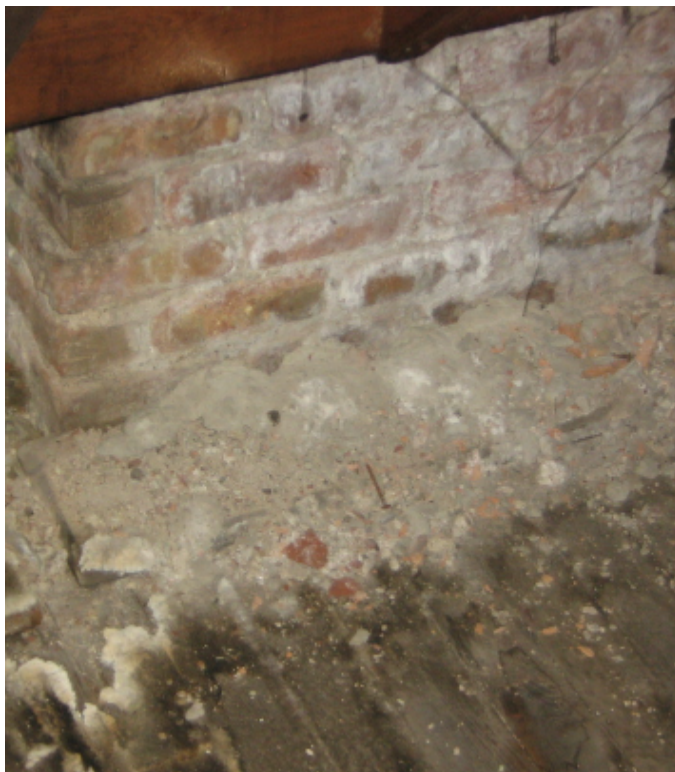
The portion of chimney located in the attic is showing signs of spalling brick and mortar and should be repaired or replaced. See the **'Hazardous Materials Maintenance Treatment Plan - Exterior'** and **'Hazardous Materials Maintenance Treatment Plan - Interior'** for locations of affected areas noted above. All activities involving asbestos or materials assumed to contain asbestos should be conducted in accordance with all local, state and federal rules and regulations.

**Photo 9:** Cracking & Deterioration of Existing Masonry Chimney Stack.

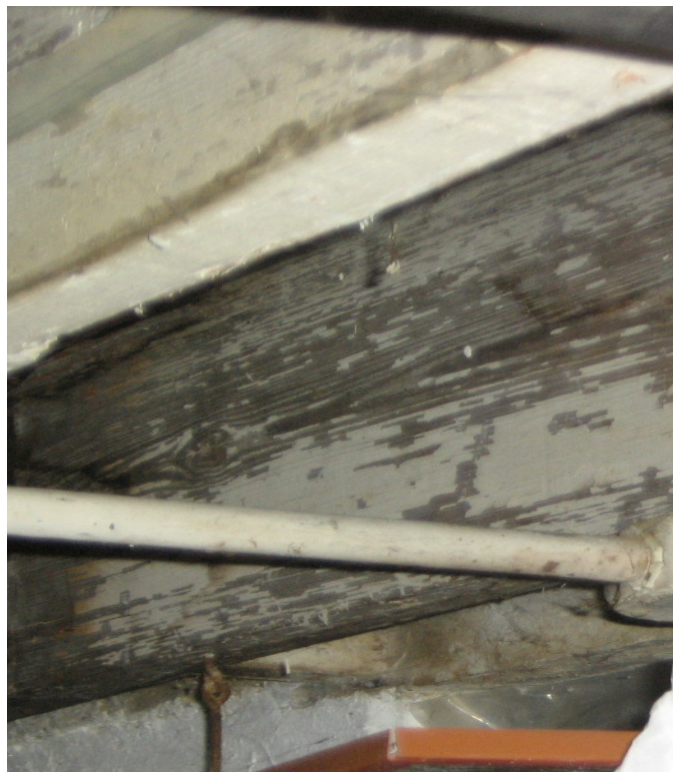
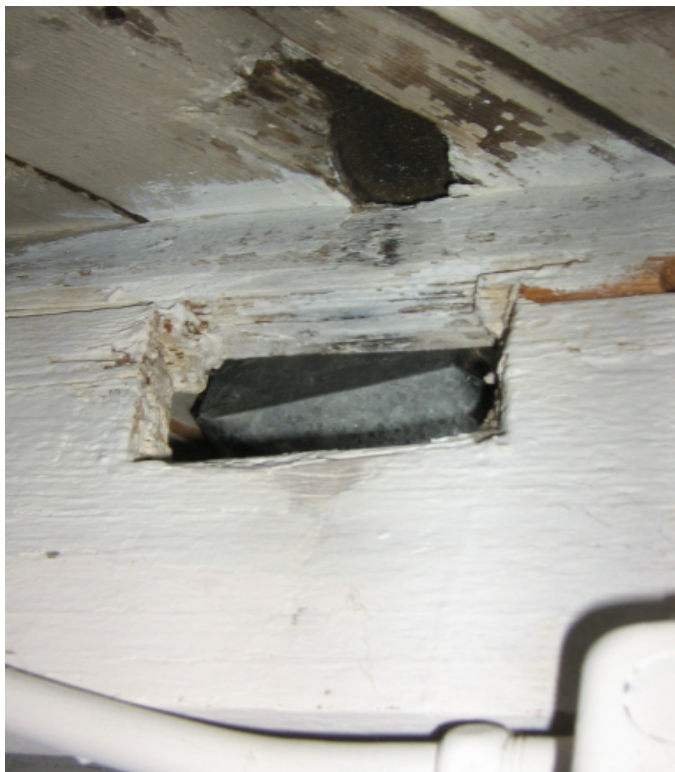
In regards to the main First Floor framing that has been left fully exposed & is readily visible from the basement, there is some evidence of moisture damage & surface deterioration as evidenced by the discoloration of the exposed wood floor joists and associated framing. In some instances, the painted finishes have begun to chip and peel away.

**Photo 10:** Deterioration of Existing Wood Floor Framing.

**Photo 11:** Deterioration of Existing Wood Floor Framing.

In general it is recommended that all structurally solid exposed interior and exterior wood framing members be cleaned and refinished to prevent further weathering and surface deterioration.

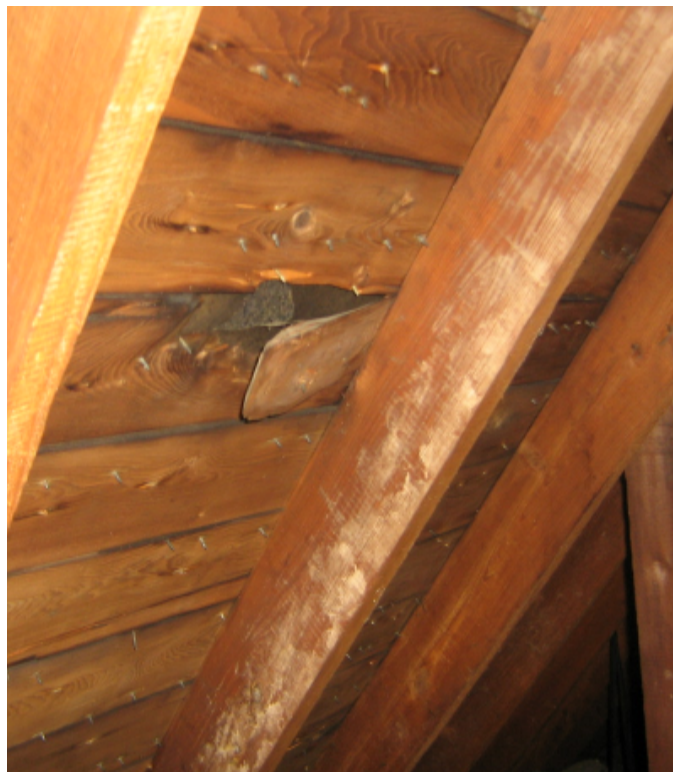
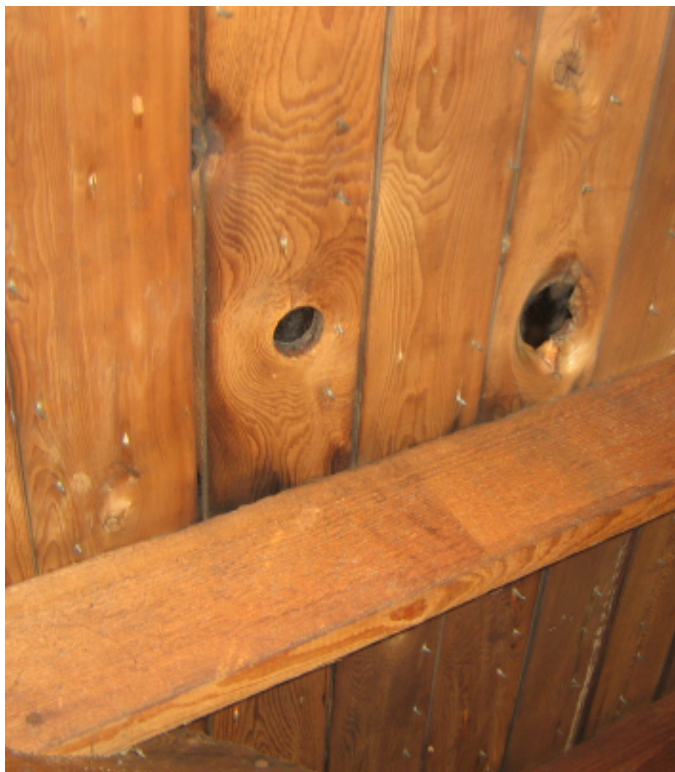
The existing wood roof framing associated with the main roof was found to be in 'good' condition. However, there is a presence of moisture damage & surface deterioration as evidence by the surface discoloration of the exposed wooden members. In addition, the roof framing members that have been left exposed to the exterior have also undergone significant moisture damage & surface deterioration. In this case, many of the painted exterior finishes are badly chipped and peeling away.

**Photo 12:** Deterioration of Existing Wood Roof Framing & Associated Roof Boards.

**Photo 13:** Deterioration of Existing Wood Roof Framing & Associated Roof Boards.

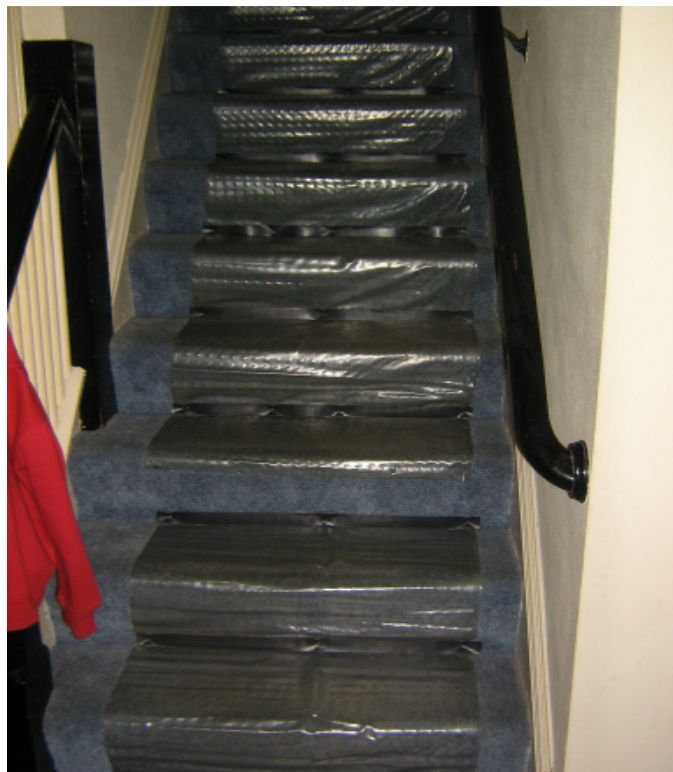
**Photo 14:** Structural Deflection & Warping of Existing Interior Stair.

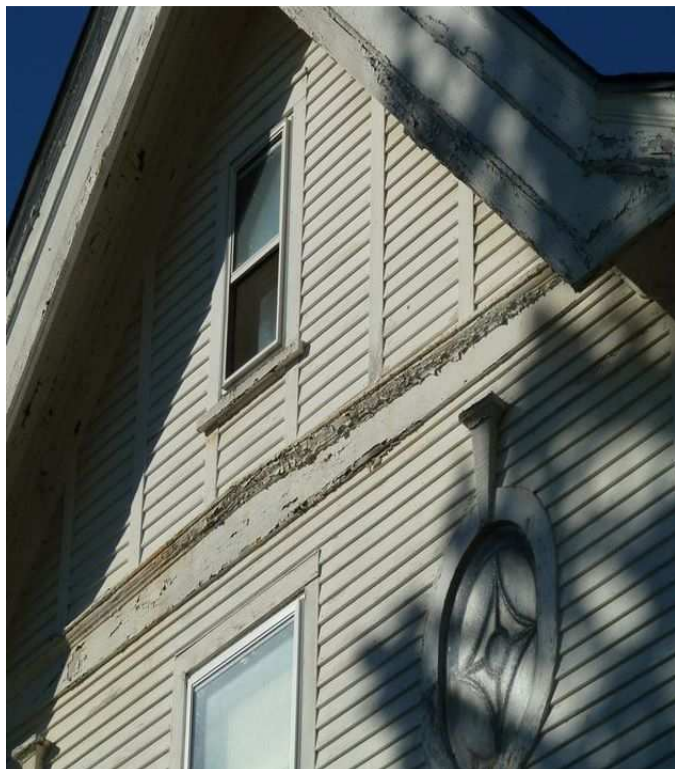
**1** Peeling paint on eaves/ trim.

Paint which has begun to peel due to a failure of the bond to the wood, plaster, or metal substrate should be removed. Paint is best removed with the careful use of metal scrapers. Sanding is usually required to eliminate rough surfaces and to smooth the transition between areas of raw wood and solid original painted surfaces. Before repainting, all raw surfaces should be primed with a tested and approved primer. This treatment should then be followed by required coat(s) of paint of the type and color to match the surrounding area. All activities must be conducted in a manner consistent with the requirements provided in 29 CFR 1926.

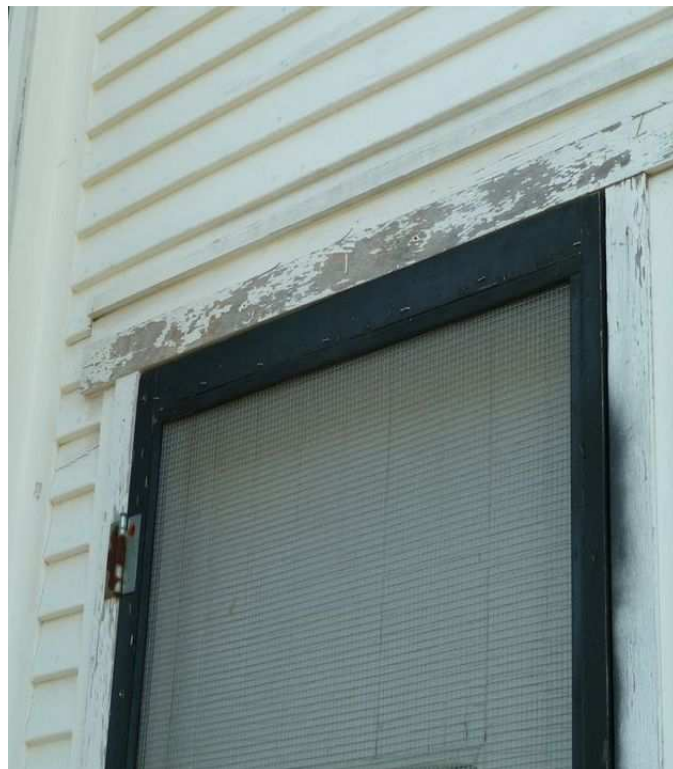
**2** Peeling paint on window frame.

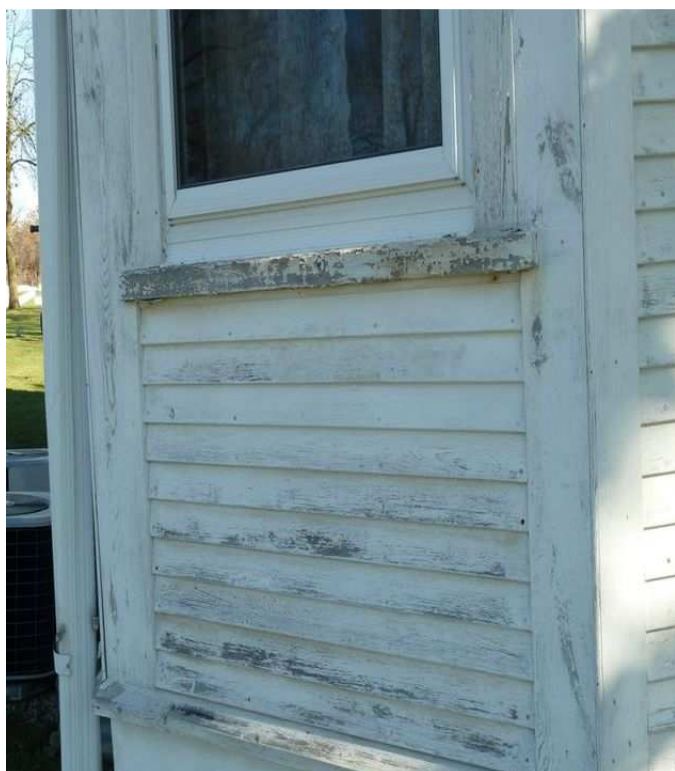
**3** Peeling paint on wood clapboards.

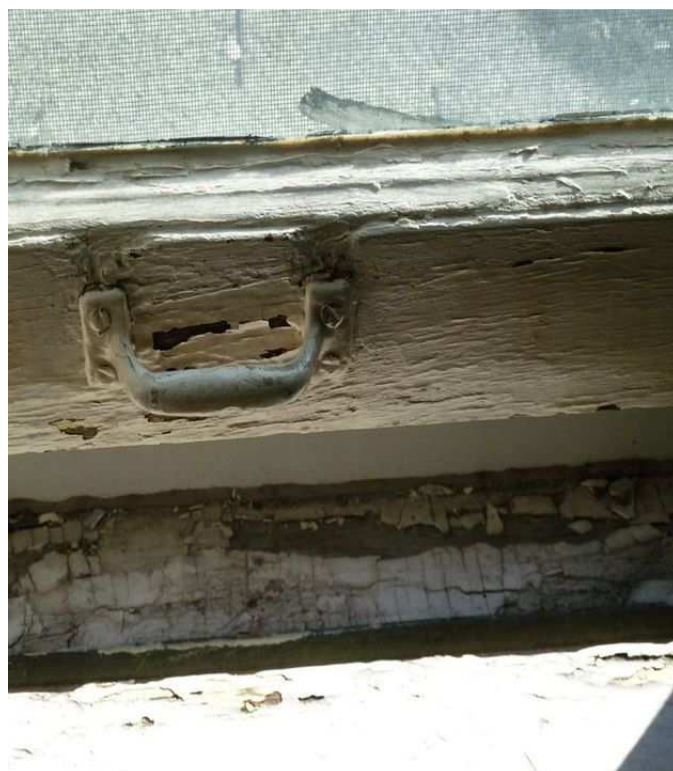
**4** Peeling paint on window frames.

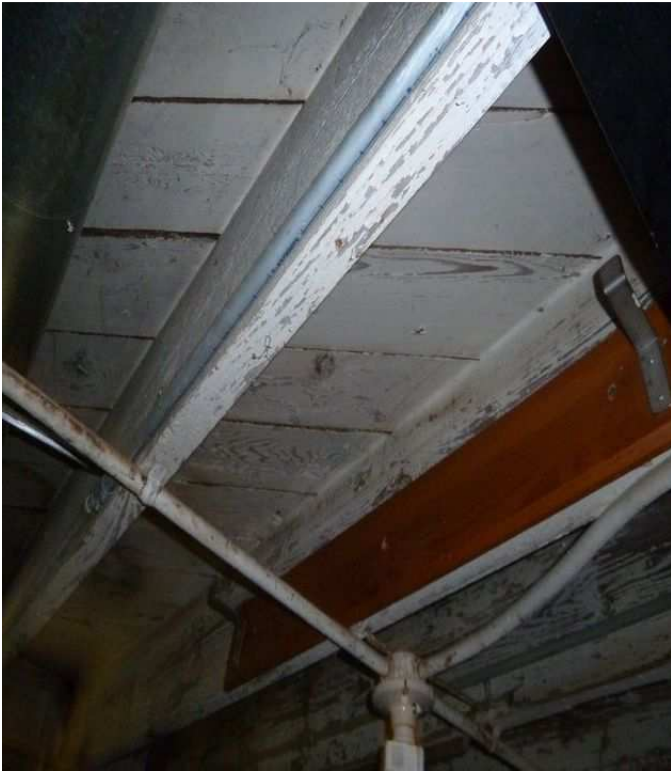
**5** *Peeling paint on wood floor joists and framing.*

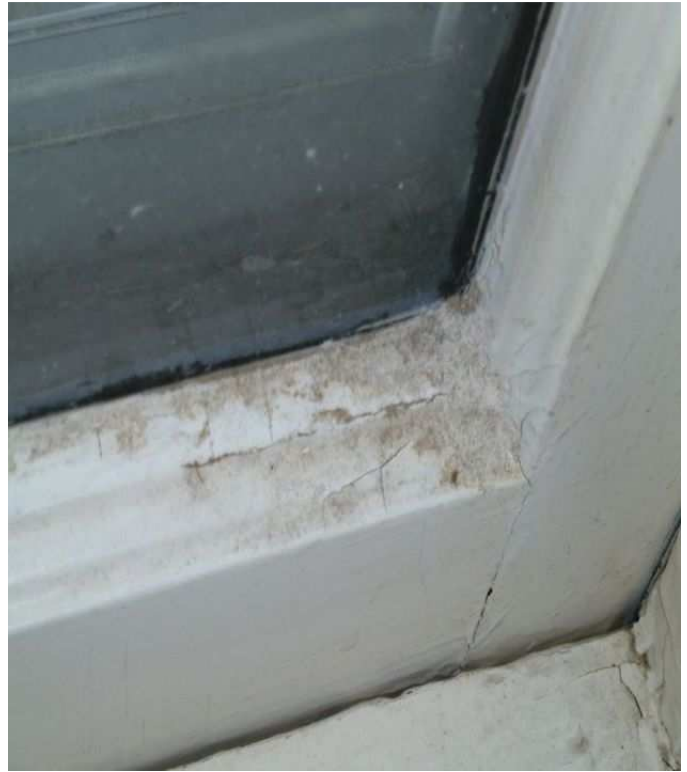
There was suspect mold growth visually observed on second floor window frames. See the **'Hazardous Materials Maintenance Treatment Plan - Exterior'** and **'Hazardous Materials Maintenance Treatment Plan - Interior'** for locations of affected areas noted above.

**6** *Suspect mold growth on window frame.*

Suspect mold growth and stained building materials implies that there is or has been water intrusion or leaks or the relative humidity within the building was high enough to cause localized or widespread condensation. It is recommended that the moisture source be located and corrected, if this has not already taken place, remove fungal-impacted building materials, and replace or repair the water stained materials.
